MAP QUALITY ASSURANCE

The package test system Dansensor® Lippke 4000 came to Omnibar's rescue

CASE STUDY OMNIBAR

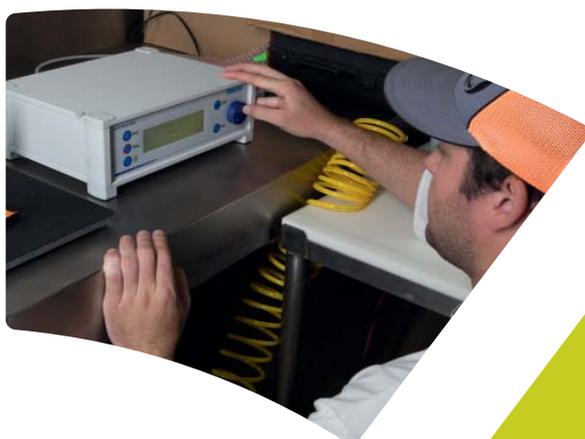
"With MOCON's leak testing and seal integrity technology we were able to identify the problem within the packaging seal and make a very fine adjustment to the packaging machine to resolve the issue," says Cooper.

"MOCON supplied Omnibar with a Dansensor Lippke 4000 machine designed to test packaging for leaks and seal strength.

The machine works by inflating the package under precisely controlled pressure and rates of inflation, automatically recording the data. The pressure within the package can be maintained at a given level; if the pressure decreases over a given time, the extent of any leakage can be gauged. Alternatively the package can be inflated until it bursts, with the point of bursting corresponding to the point of failure on the packaging. "With MOCON's leak testing and seal integrity technology we were able to identify the problem within the packaging seal and make a very fine adjustment to the packaging machine to resolve the issue," says Cooper.
